Residential Building Walls and Environment in Amman, Jordan

Abstract

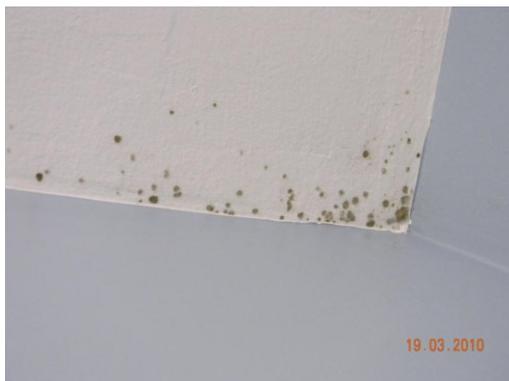
Ceiling

Fig. 1. Images of some samples of moisture traces and molds growth on ceiling and walls of residential buildings

It is interesting to see occasional drop of wall inside surface temperature close to or below dew-point temperature, this indicates condensation on the walls surface. This phenomenon is likely to happen more near the ceiling where the air temperature is slightly higher than measured values at head level. Traces of moulds growth are usually seen at the ceiling edge extending down on walls and at window edges, also behind drawers and curtains encouraged by still air, see images below.
